## Using video-graphic technique for the Pedestrian Safety Analysis (PSA) at mid-block crossings in urban areas of developing countries under mixed traffic conditions

**Badveeti Adinarayana<sup>1\*</sup>, Dr. Mohammad Shafi Mir<sup>2</sup>**

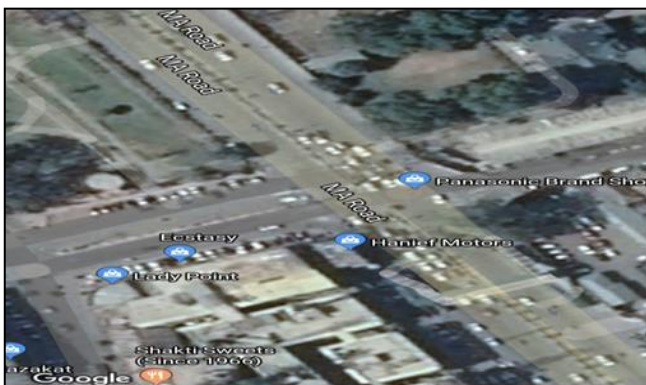
**Fig 1:** Midblock Crossing at M.A. Road Kothi Bagh.

**Location One:** Midblock crossing M A Road, Kothi Bagh

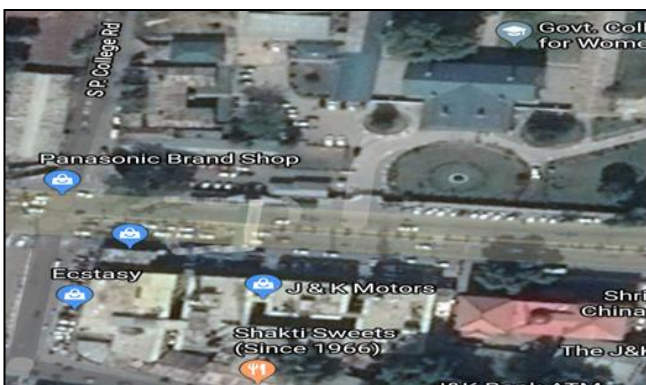
**Fig 2:** Foot Over Bridge near Women’s College.

**Location Two:** Foot Over Bridge near Women’s College

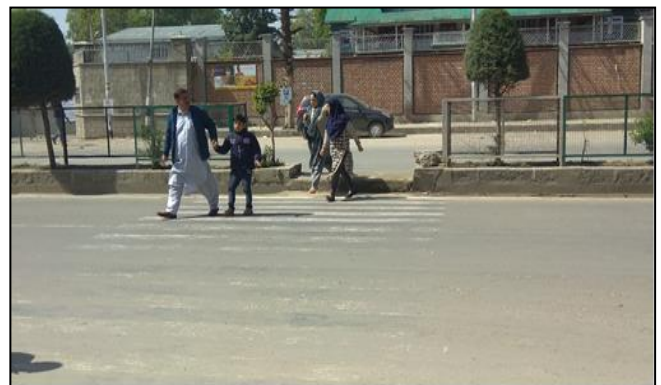
**Fig 3:** Midblock Crossing at M.A. Road Kothi Bagh.

- Poor visibility of the road markings for the pedestrian at the midblock crossings.
- Absence of traffic signs.
- Absence of traffic signals.
- Absence of STOP line and road humps.
- No special provision for the physically disabled people.
- Speed of the traffic is high so that pedestrian face lot of difficulties while crossing the road especially during the peak hours.
- Surface condition of the road is not good. It becomes slippery in wet condition.

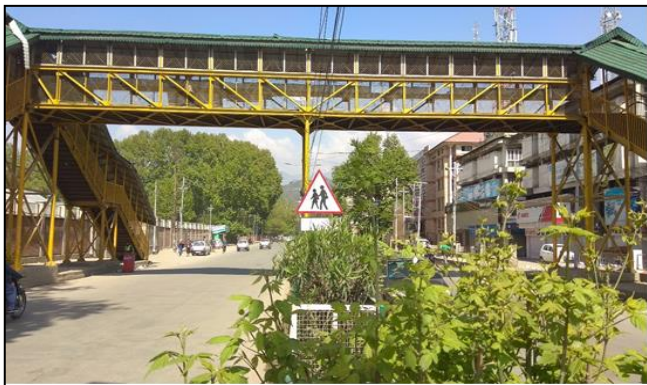
**Fig 4:** Foot Over Bridge Near Govt. College for Women.

- Traffic sign is present but its visibility is very low.
- The surface condition of the foot over bridge is very poor.
- Lighting facilities is absent at the foot over bridge so pedestrian have to face difficulties while travelling in the dark conditions.
- No special provision for the physically disabled people.

- The stairs of the foot over bridge is poor.
- No special provision for the elderly and physically challenged people for crossing the foot over bridge.
- Insufficient space for on-street parking.
- Length of the foot over bridge: 26.18 m
- Width of the foot over bridge: 2.39 m
- Width of the stairs: 1.89 m
- Height of the stairs: 0.22 m

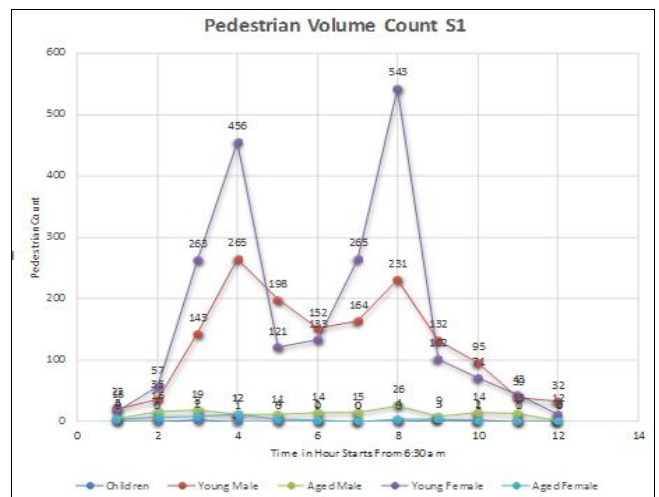
**Fig 6:** Line chart for Pedestrian volume of various age group vs time duration at site 1.

Average crossing speed is 1.2 to 1.55 m/sec  
 Total pedestrian volume is 2595  
 Peak pedestrian volume is 804 (both directions)  
 Age group  
 Gender- male, female, young male, aged male, young

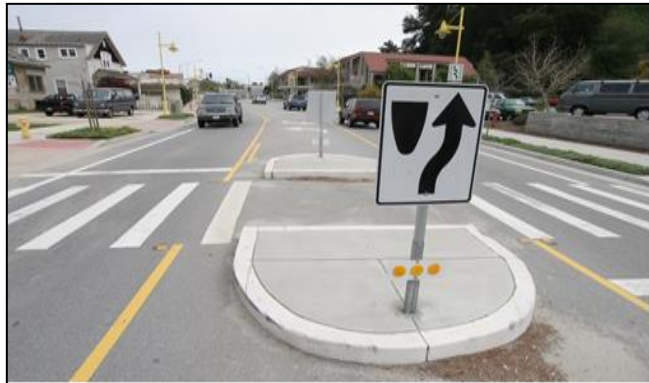
**Fig 8:** Refuge Island.

roadway at midblock locations. Refuge islands are intended to assist pedestrians in crossing wide streets by providing a safe “refuge” in the centre of the road, allowing pedestrians to cross one direction of traffic at a time. The presence of a refuge island reduces the time a pedestrian must wait for an adequate gap in the traffic stream and reduces the crossing distance that they must face at one time. Pedestrian refuge islands are particularly suitable near pedestrian generators such as hospitals, schools, malls, etc., and may form part of a larger street scraping plan.

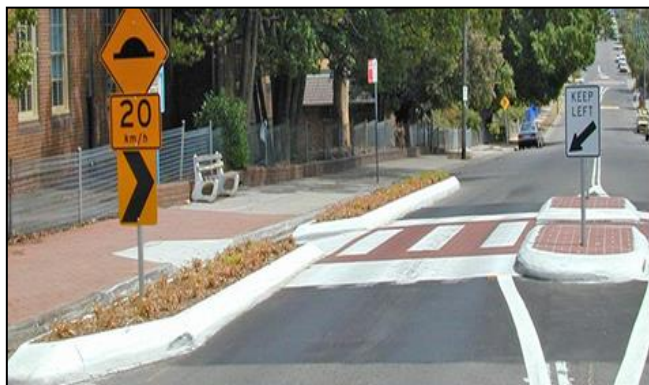
**Fig 9:** Kerb extension

Kerb extensions “extend” the sidewalk or kerb line at specific points to reduce the width of the travelled portion of the roadway or extend out into the spaced allocated for kerb side parking. Kerb extensions reduce the distance pedestrians have to walk, hence pedestrians require smaller gaps in traffic in order to cross and pedestrian delays are likely to be shorter. Kerb extensions can provide a refuge for pedestrians, improve the sight distance and sight lines for both pedestrians and motorists, and may also be considered as a traffic calming measure.

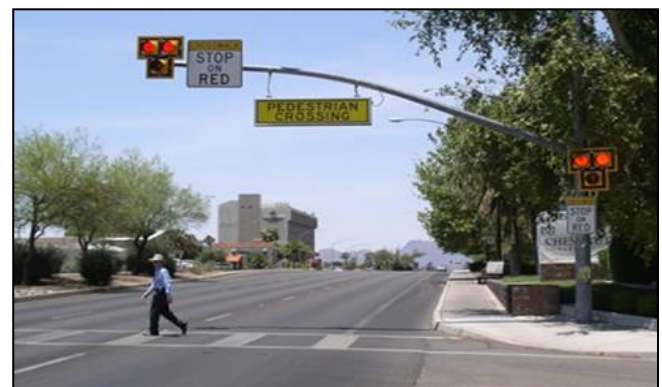
**Fig 11:** Pedestrian warning signs.

Warning signs are used to alert drivers to danger or potential danger ahead. They indicate a need for extra caution by road users and may require a reduction in speed or other man oeuvre. This section contains advice on when to use each sign. Adequate warning signs can greatly assist road safety. To be most effective however, they should be used sparingly.

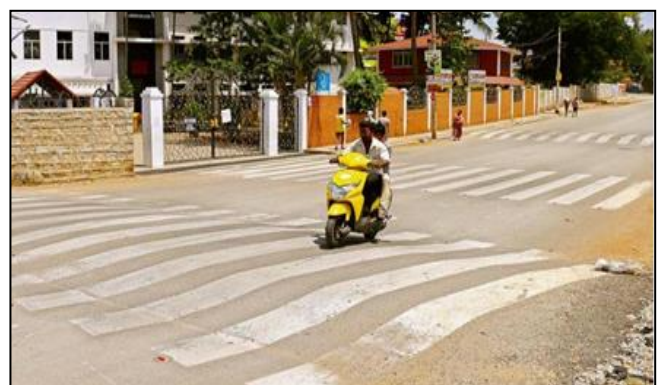
**Fig 12:** Speed breaker.

These are the small undulations which are made on the surface on the road, due to which drivers of the vehicles are forced to reduce the speed of their vehicles.

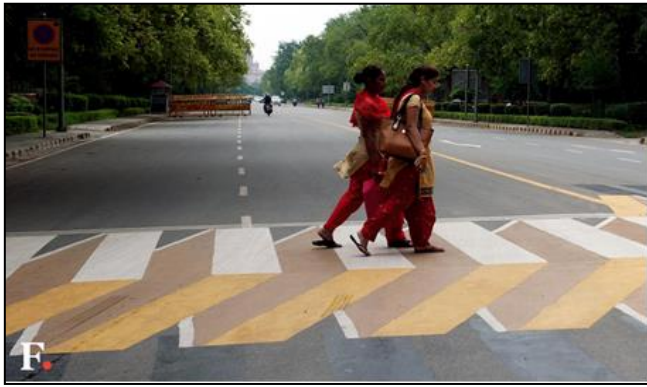
**Fig 13:** 3D Paint for pedestrian mid-block crossings.

This type of paint can be used to give an illusion of some

obstruction to the driver when he is speeding up.
