Evaluation of maintenance of Niger state library complex, Minna, Nigeria

Abstract

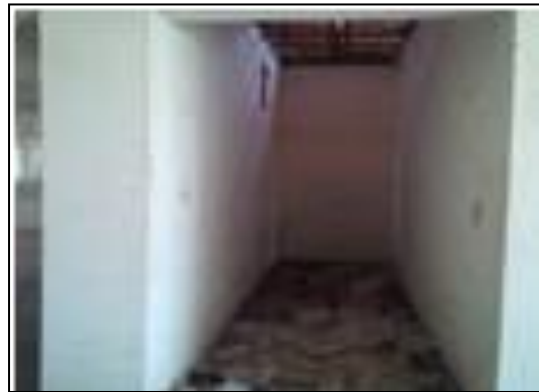
It was observed that the interior parts of the library complex are spacious, and the environment of the library complex was clean. However, some of the ceiling tiles have been removed at the first floor of the library complex. Similarly, the wall paint is faded up and in some places the paint is already peeling out of the wall, especially at the entrance. Fig 1 shows the removed ceiling tiles, and Fig 2 shows the faded and peeling wall paint.

Fig 1: The Removed Ceiling Tiles (Source: Authors' Field Work, 2018).

- i) The government should adequately maintain the libraries in Nigeria.

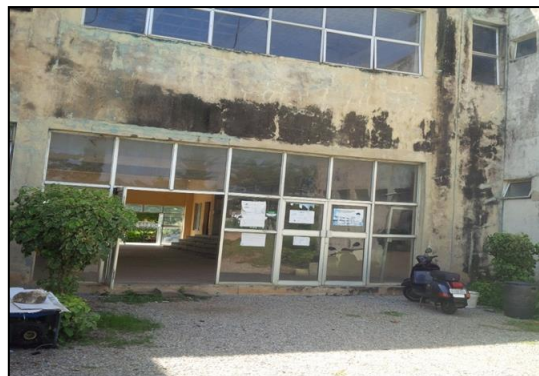
Fig 2: Faded and Peeling Wall Paint (Source: Authors' Field Work, 2018).

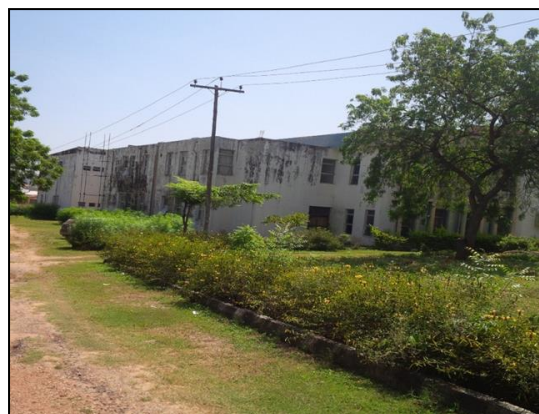
It was observed that there are cracks on the first floor. The access road to the library complex is not tarred or covered with any other hard surface, and this led to the growing of grasses on it; there are no drainages for ground water control around the library complex. Fig 3 shows the access road to the library complex with grasses growing on it.

Fig 3: Access Road to the Library Complex with Grasses Growing on it (Source: Authors' Field Work, 2018).

- ii) The access roads to the Nigerian libraries should be tarred or covered with any other hard surface to avoid the growing of grasses on them.
- iii) Library complexes in Nigeria should be designed to have drainages for ground water control.
